TOWN OF HILLSBORO COMMUNITY DEVELOPMENT BLOCK DEMOLITION BID PACKET

ASBESTOS INSPECTION REPORT

FORMER HILLSBORO BANK
44 DENMAR ROAD
HILLSBORO, WEST VIRGINIA

August 14, 2020

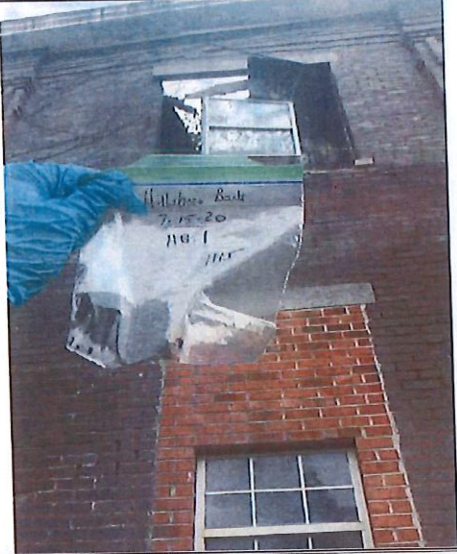
Date: 07/15/20	
Comments: Sample HB-1 Roofing Felt Main Roof	
Photographer: SAW

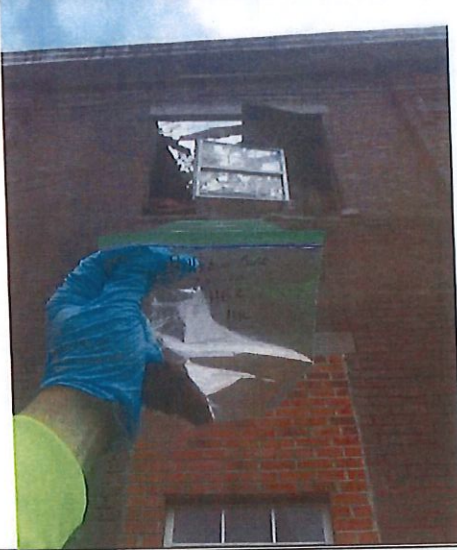
Date: 07/15/20	
Comments: Sample HB-2 Roofing Felt Main Roof

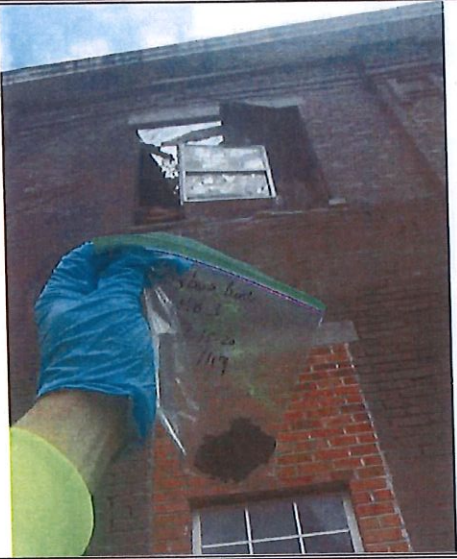
Date: 07/15/20	
Comments: Sample HB-3 Roofing Felt Main Roof	
Photographer: SAW

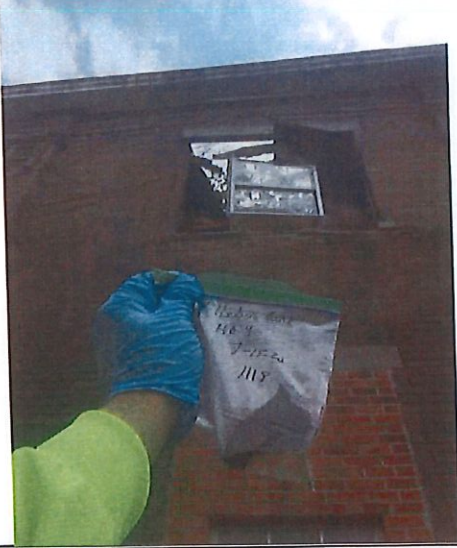
HB-4 / Brown Tar-based Roofing Material	Main Roof	Poor	No	~1,500 sf.	10%
HB-5 / Brown Tar-based Roofing Material	Main Roof	Poor	No		10%
HB-6 / Brown Tar-based Roofing Material	Main Roof	Poor	No		10%
HB-7 / Exterior Stairwell Roof Shingles	Exterior Basement Stairwell Roof	Fair	No	~42 sf.	NAD
HB-8 / Exterior Stairwell Roof Shingles	Exterior Basement Stairwell Roof	Fair	No		NAD
HB-9 / Exterior Stairwell Roof Shingles	Exterior Basement Stairwell Roof	Fair	No		NAD
HB-10 / Plaster Sampled 1 st Floor NW Corner of Bldg.	Entire Structure (Assumed)	Poor	Yes	Unknown	2%
HB-11 / Plaster Sampled 1 st Floor NW Corner of Bldg.	Entire Structure (Assumed)	Poor	Yes		2%
HB-12 / Plaster Sampled 1 st Floor NW Corner of Bldg.	Entire Structure (Assumed)	Poor	Yes		2%
HB-13 / Drywall Sampled 1 st Floor NW Corner of Bldg.	Entire Structure (Assumed)	Poor	No	Unknown	NAD
HB-14 / Drywall Sampled 1 st Floor NW Corner of Bldg.	Entire Structure (Assumed)	Poor	No		NAD

Date: 07/15/20	
Comments: Sample HB-4 Roofing Material Main Roof

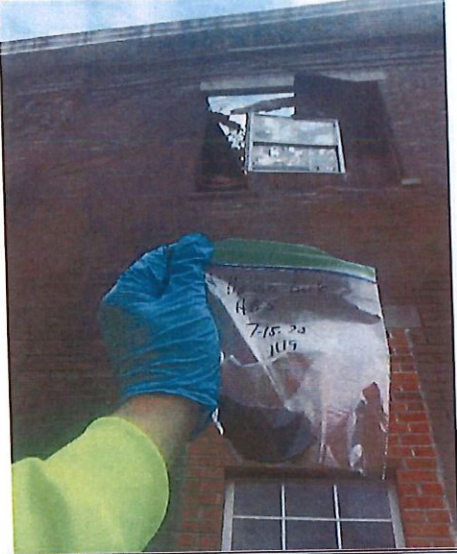
Date: 07/15/20	
Comments: Sample HB-5 Roofing Material Main Roof	
Photographer: SAW

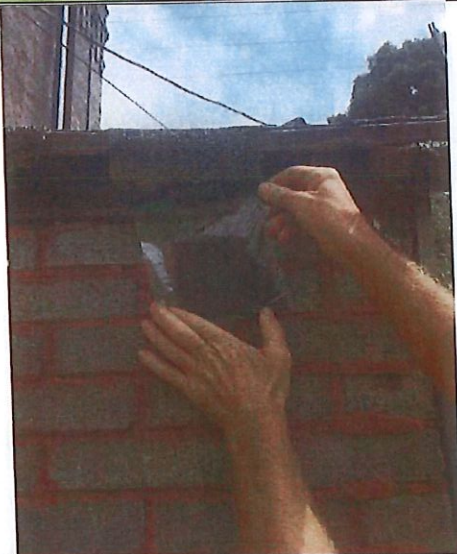
Date: 07/15/20	
Comments: Sample HB-7 Rear Roofing Shingles Basement Stairwell Enclosure Roof

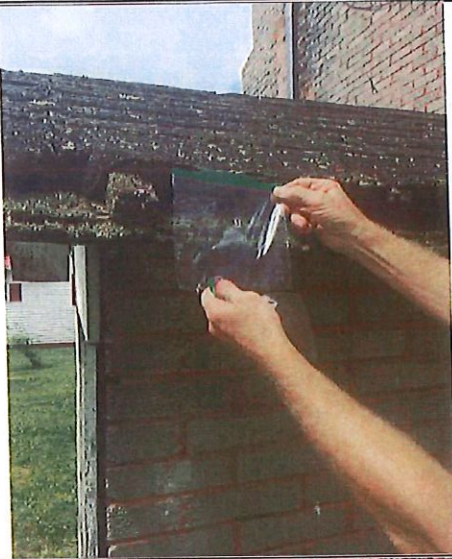
Date: 07/15/20	
Comments: Sample HB-8 Rear Roofing Shingles Basement Stairwell Enclosure Roof	
Photographer: SAW

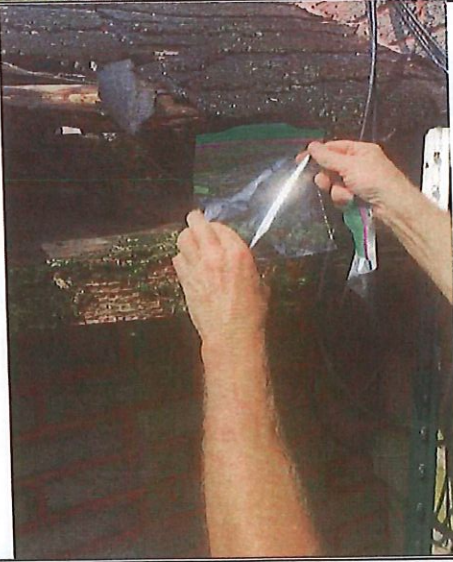
Date: 07/15/20	
Comments: Sample HB-9 Rear Roofing Shingles Basement Stairwell Enclosure Roof

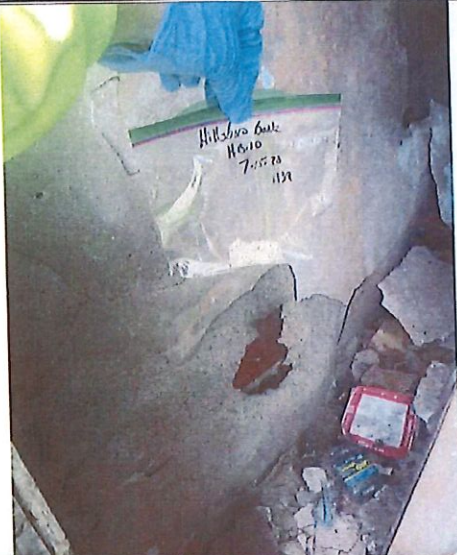
- Samples HB-10 through HB-12 represent plaster walls and ceilings that were determined to contain 2% asbestos. These samples were collected from the 1st floor wall near the interior northwest corner entrance of the building. Due to the dilapidated, unsafe condition of the structure, a square footage could not be determined for the plaster surfaces; and

Date: 07/15/20	
Comments: Sample HB-10 Plaster Wall Covering First Floor Rear NW Corner	
Photographer: SAW

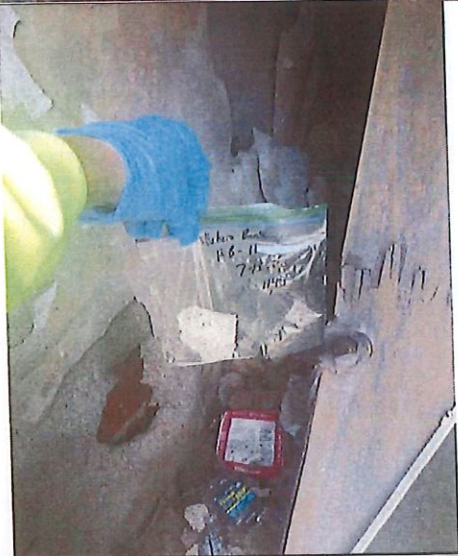
Date: 07/15/20	
Comments: Sample HB-11 Plaster Wall Covering First Floor Rear NW Corner

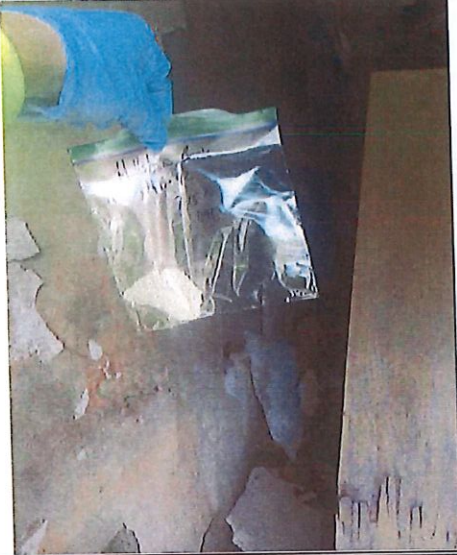
Date: 07/15/20	
Comments: Sample HB-12 Plaster Wall Covering First Floor Rear NW Corner	
Photographer: SAW

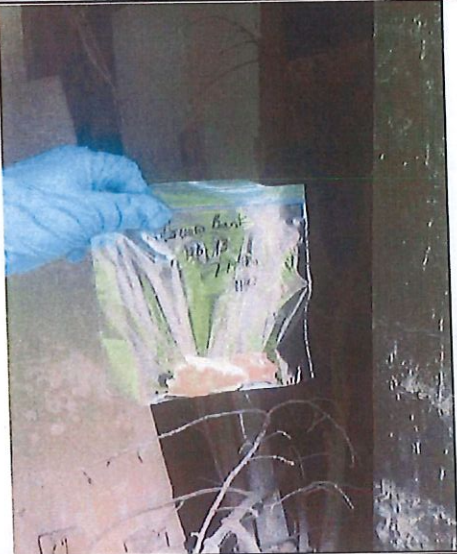
Date: 07/15/20	
Comments: Sample HB-13 Drywall Sample First Floor Rear NW Corner

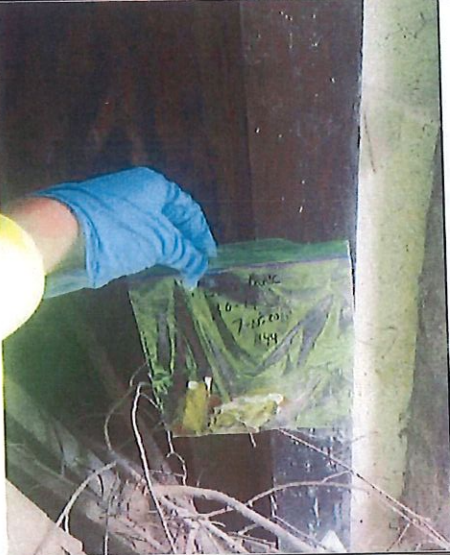
Date: 07/15/20	
Comments: Sample HB-14 Drywall Material First Floor Rear NW Corner	
Photographer: SAW

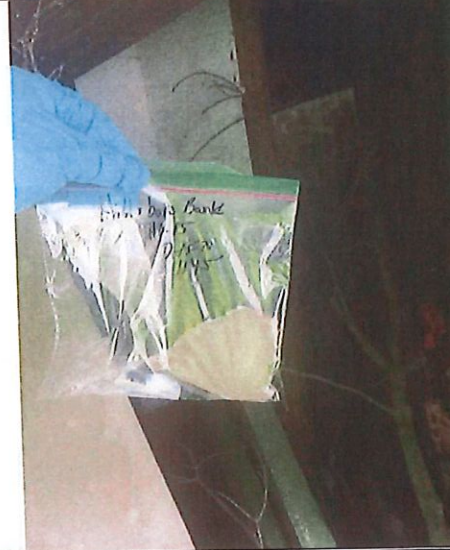
Date: 07/15/20	
Comments: Sample HB-15 Drywall Material First Floor Rear NW Corner

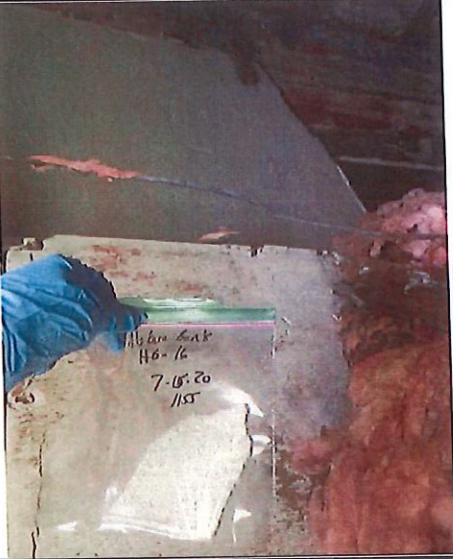
- Samples HM16 through HB-19 represent plaster walls and ceilings that were determined to contain 2% asbestos. These samples were collected from the 1st floor wall near the interior southwest corner entrance of the building. Due to the dilapidated unsafe condition of the structure, a square footage could not be determined for the plaster surfaces.

Date: 07/15/20	
Comments: Sample HB-16 Plaster First Floor SW Corner	
Photographer: SAW

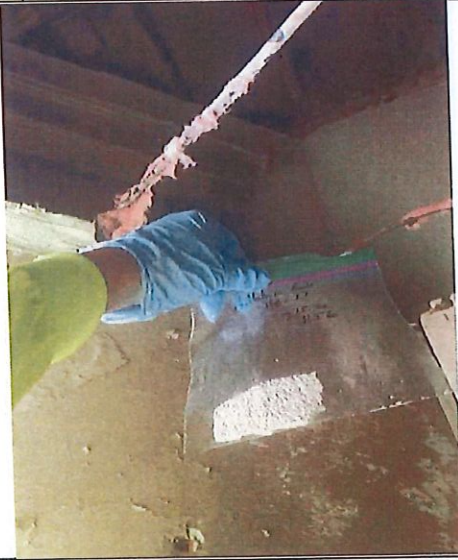
Date: 07/15/20	
Comments: Sample HB-17 Plaster First Floor SW Corner

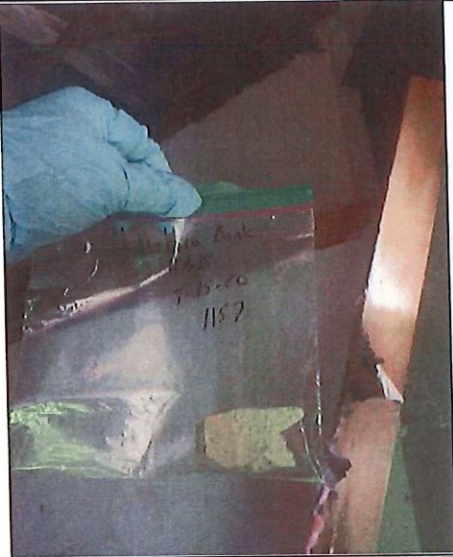
Date: 07/15/20	
Comments: Sample HB-18 Plaster First Floor SW Corner	
Photographer: SAW

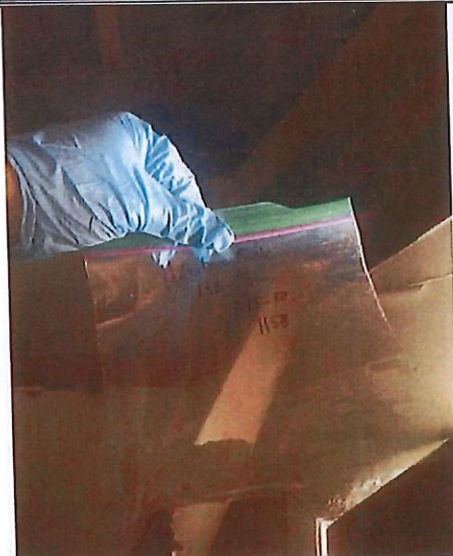
Date: 07/15/20	
Comments: Sample HB-19 Plaster First Floor SW Corner

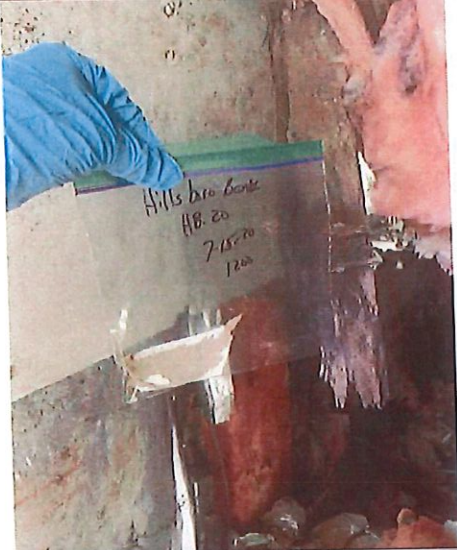
Date: 07/15/20	
Comments: Sample HB-20 Drywall First Floor SW Corner	
Photographer: SAW

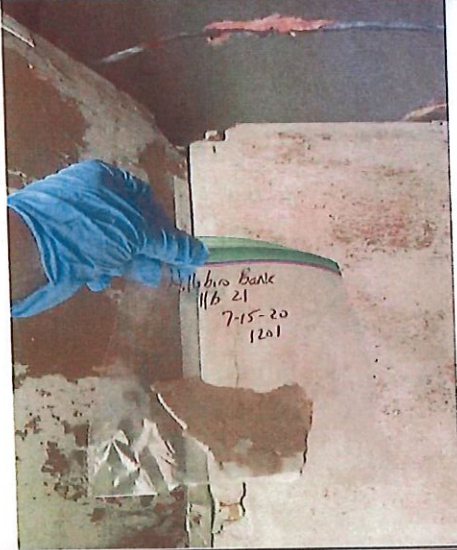
Date: 07/15/20	
Comments: Sample HB-21 Drywall First Floor SW Corner

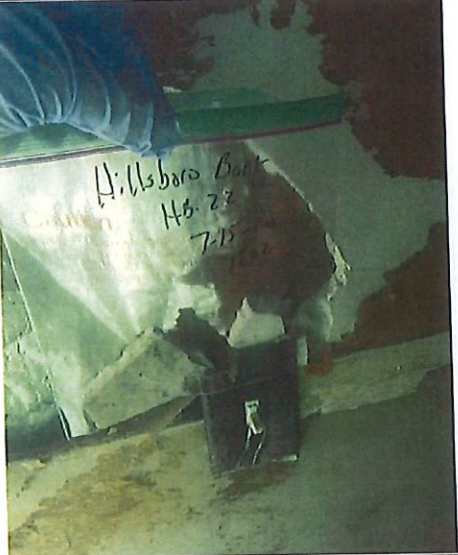
Date: 07/15/20	
Comments: Sample HB-22 Drywall First Floor SW Corner
