TOWN OF HILLSBORO COMMUNITY DEVELOPMENT BLOCK DEMOLITION BID PACKET

ASBESTOS INSPECTION REPORT

FORMER HILLSBORO BANK
44 DENMAR ROAD
HILLSBORO, WEST VIRGINIA

August 14, 2020

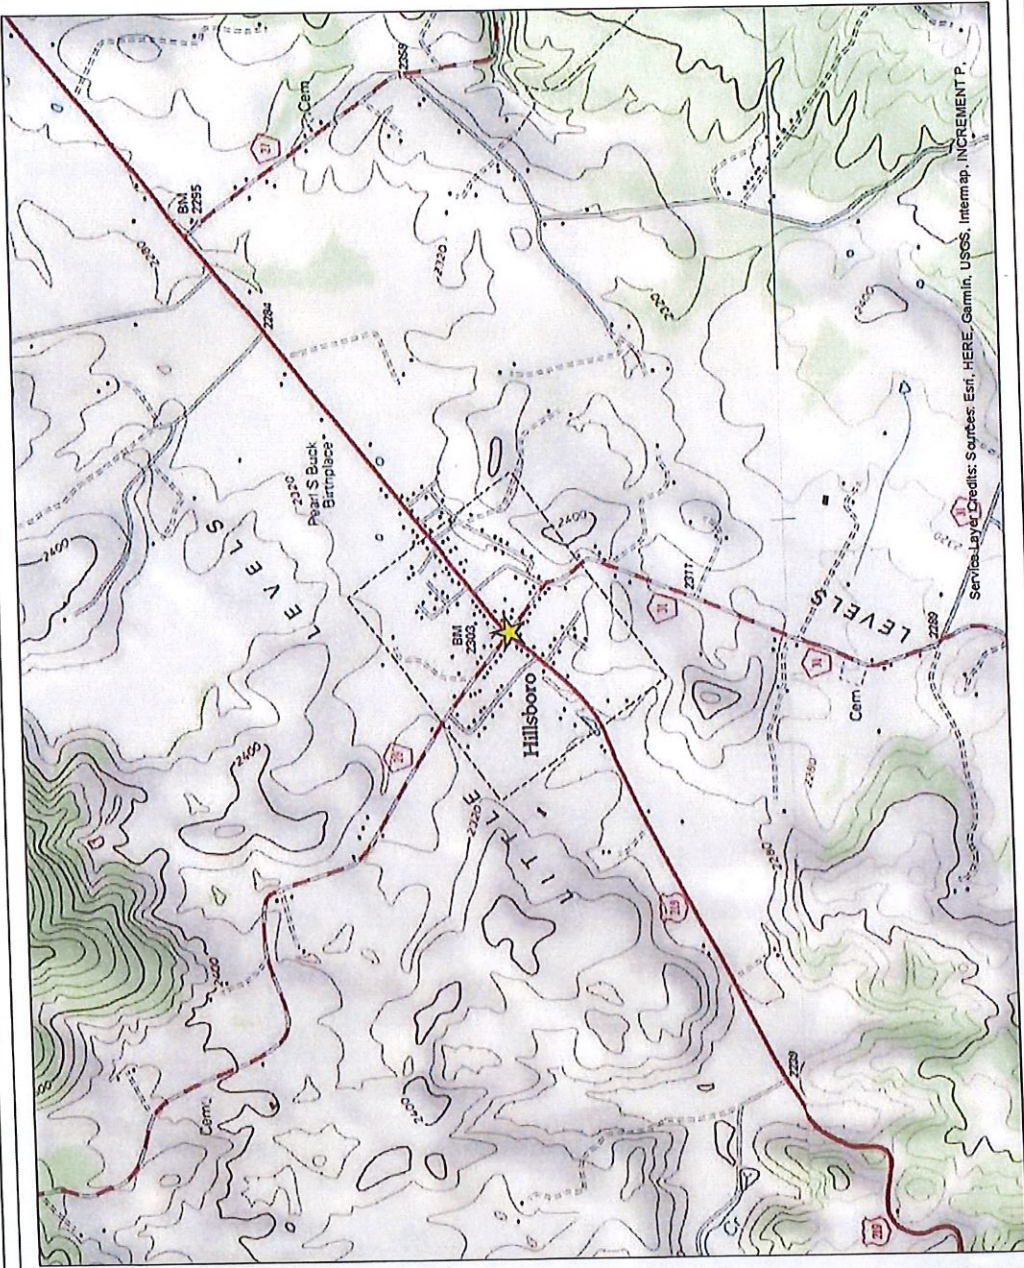
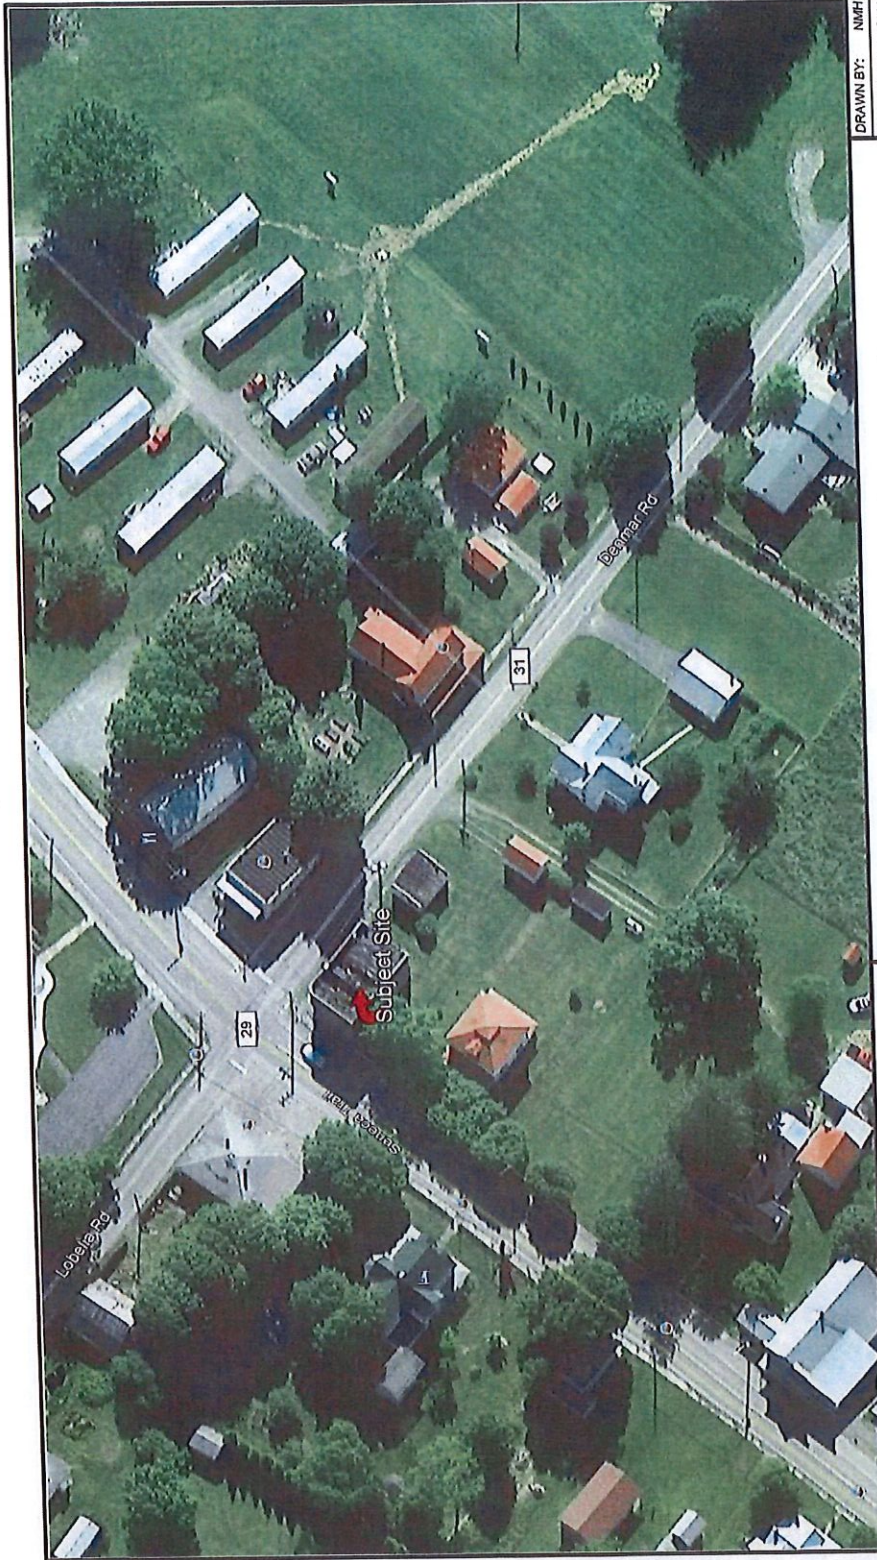
Figure 2 - Hillsboro Bank Property
44 Denmar Road, Hillsboro, WV
Site Map

Sample locations are included in Figure 2. Copies of the laboratory analytical report and corresponding chain-of-custody are included in Appendix B. Results are reported in percent asbestos by volume and indicate the types of asbestos. Other common non-asbestos components may also be noted on the analytical reports. Inspector and laboratory accreditations are provided in Appendix C.
